Federal Building and Fire Safety Investigation of the World Trade Center Disaster

**Dr. William Grosshandler
Building and Fire Research Laboratory
National Institute of Standards and Technology
U.S. Department of Commerce**

October 3, 2005

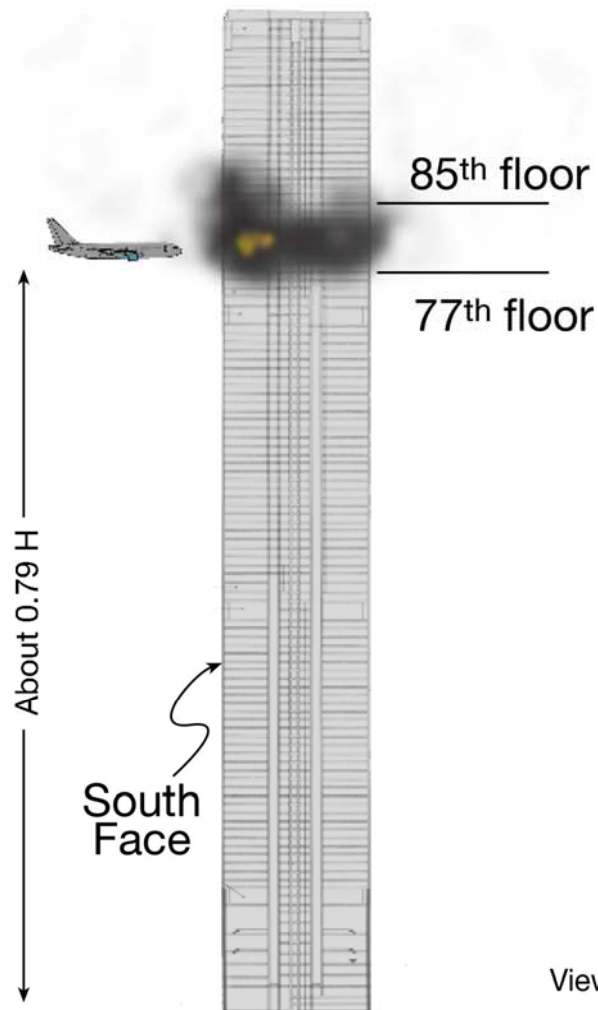
WTC 2: Hit at 9:02:59 a.m.
Collapsed after 56 minutes

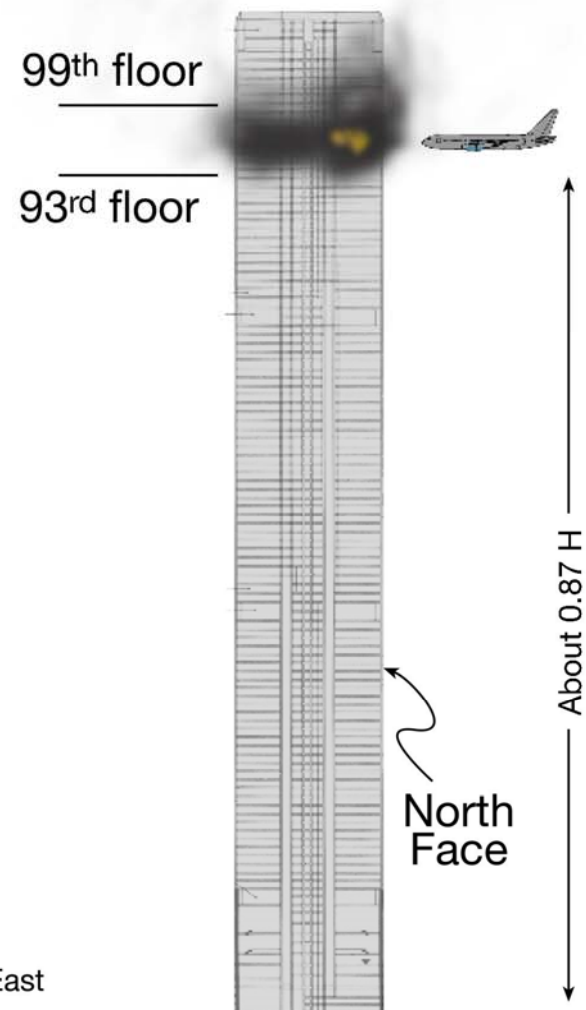
WTC 1: Hit at 8:46:30 a.m.
Collapsed after 102 minutes

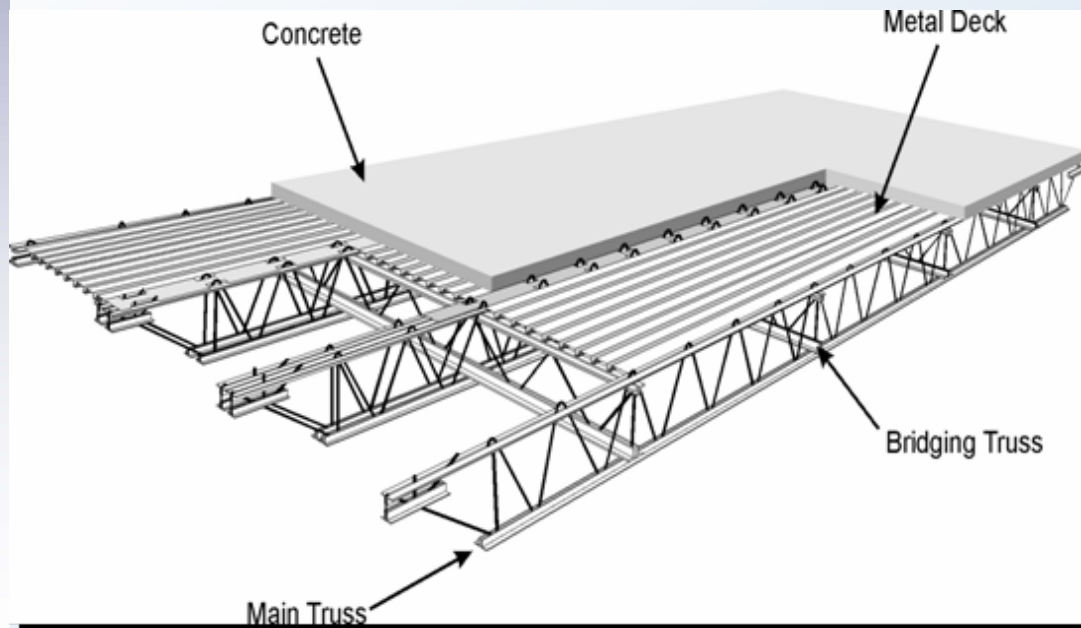
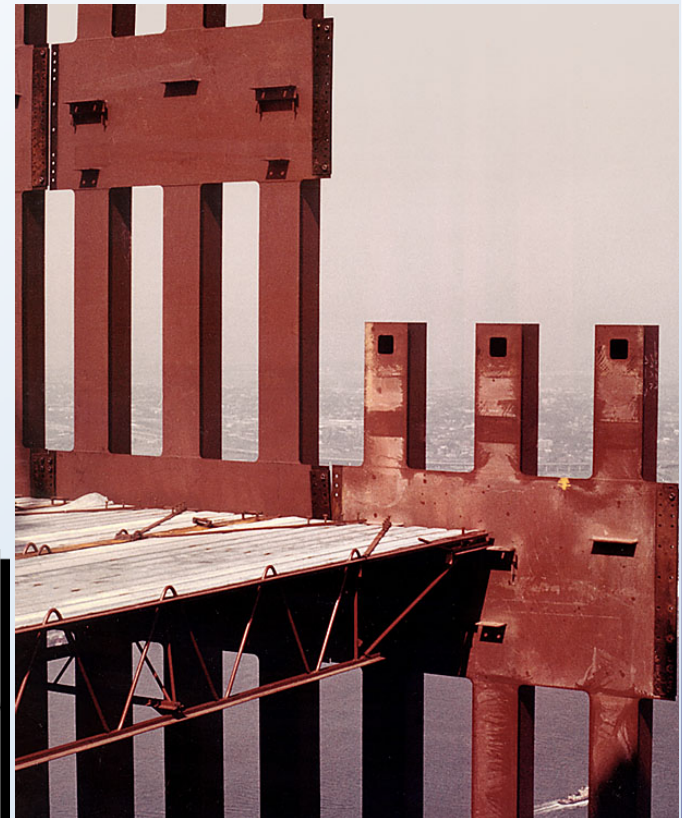
Composite floor truss system
using long span open-web bar
joists and spray-applied
fireproofing

Floors attached to
perimeter column trees

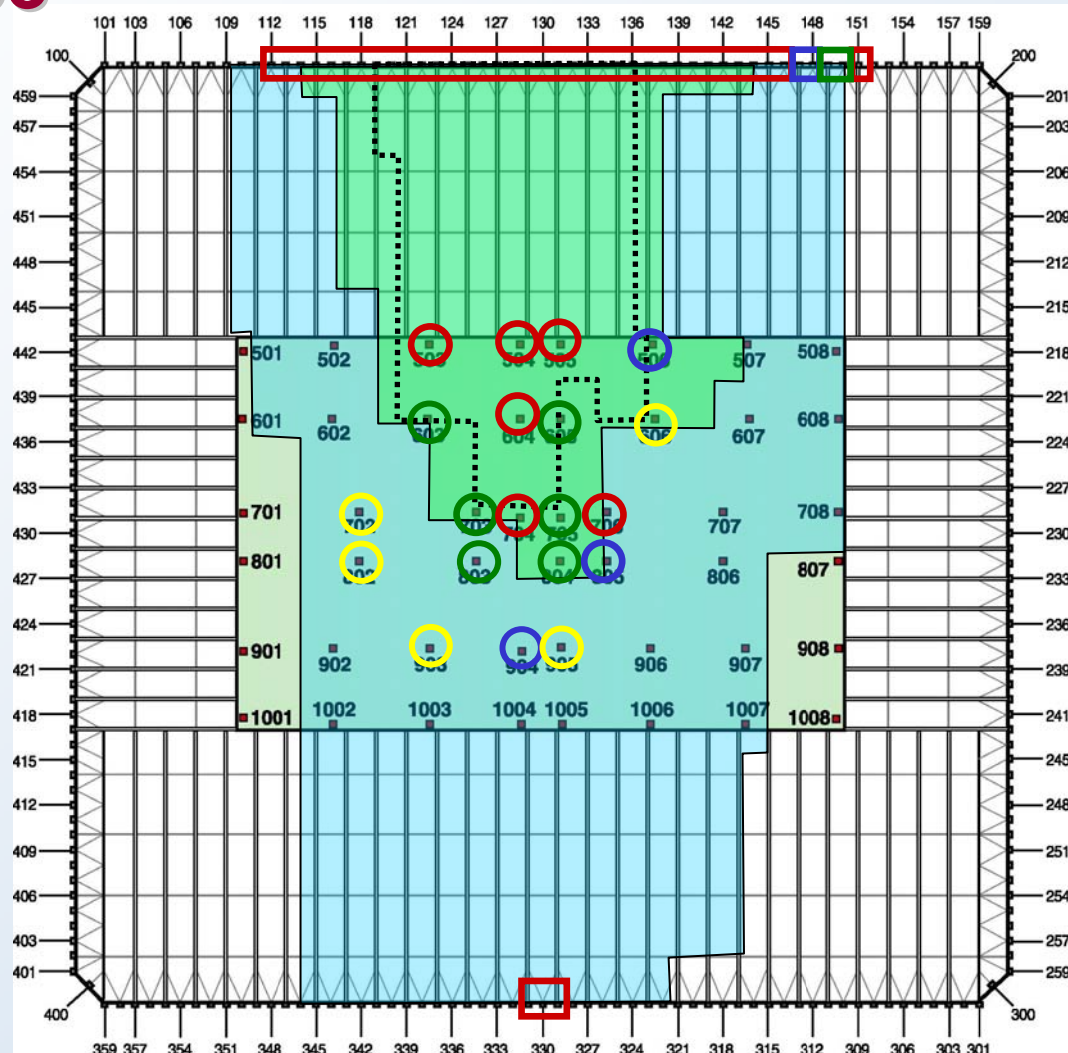
WTC 1 Damage: Composite Summary for Floors 93 to 98

Severe Floor Damage

Column Damage

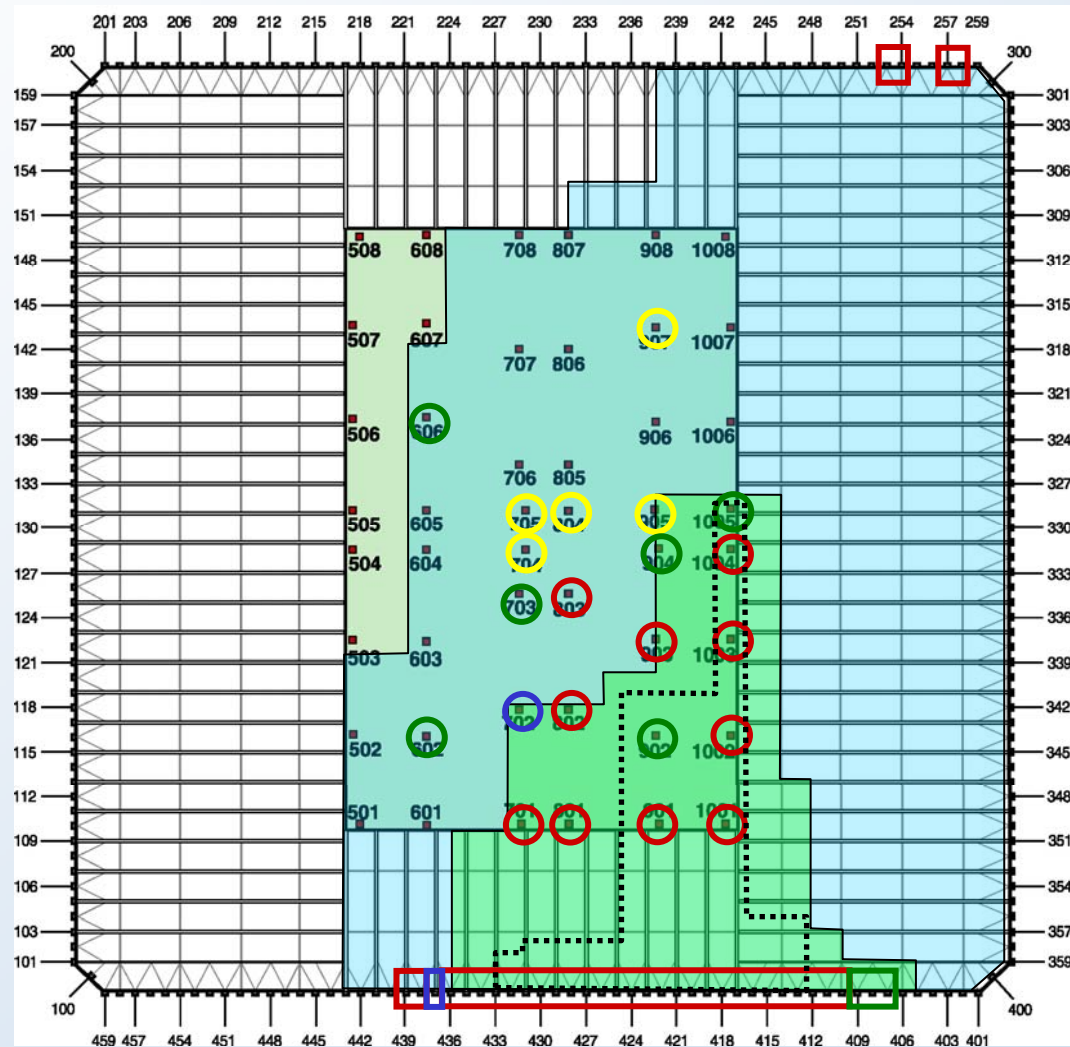
WTC 2 Damage: Composite Summary for Floors 78 to 83

Floor Damage

Column Damage

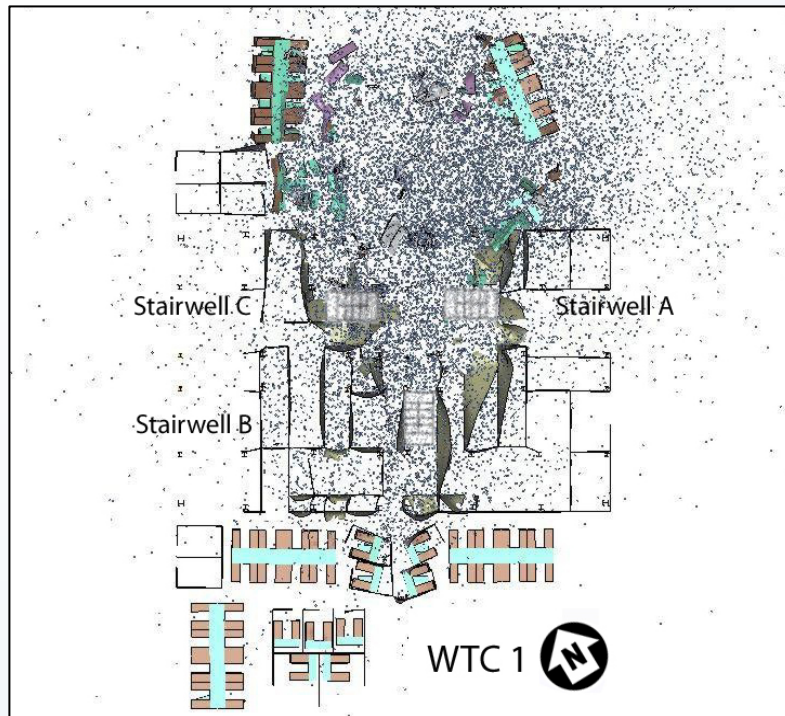
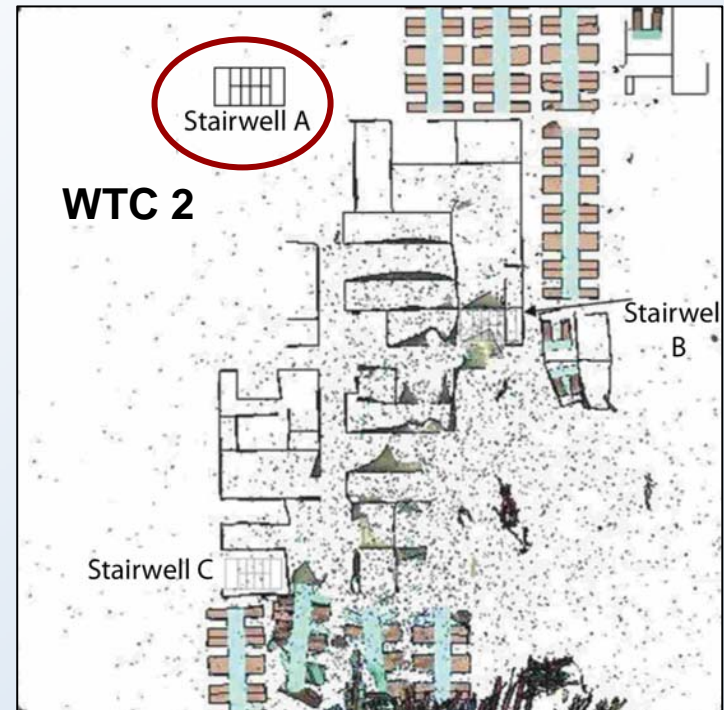
Condition of Stairwells

- Stairwells, with partition wall enclosures that provided 2 h fire-rating but little structural integrity, were damaged in region of aircraft impacted floors.
- **Stairwell A on the Northwest side of WTC 2 was passable in region of aircraft impact for some period of time after attack.**
- All three stairwells in WTC 1 and the two other stairwells in WTC 2 were rendered impassable in the region of aircraft impact.

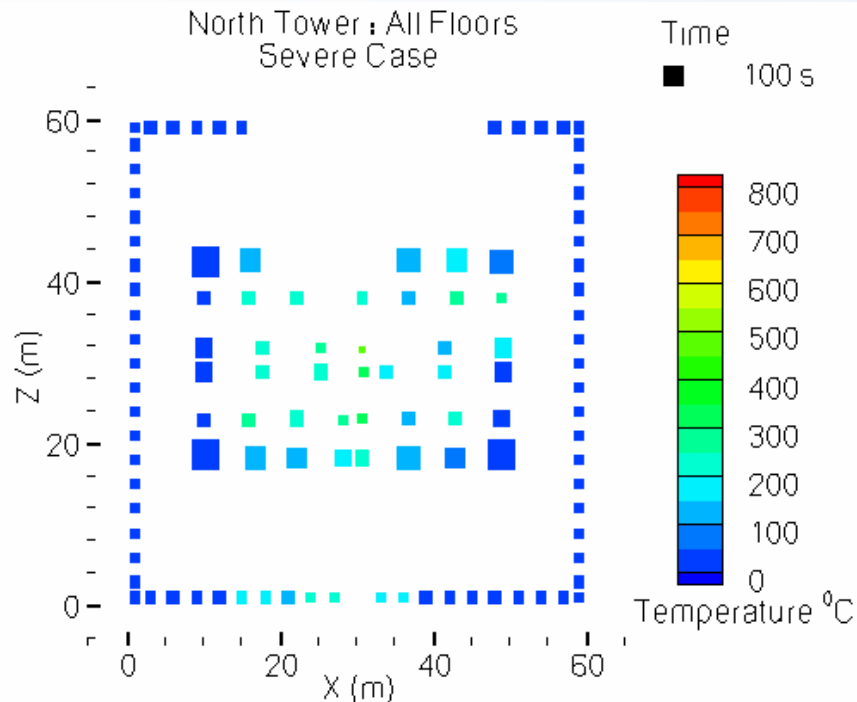
WTC 1

Predicted Column Temperatures

Shows maximum temperature reached by each column.

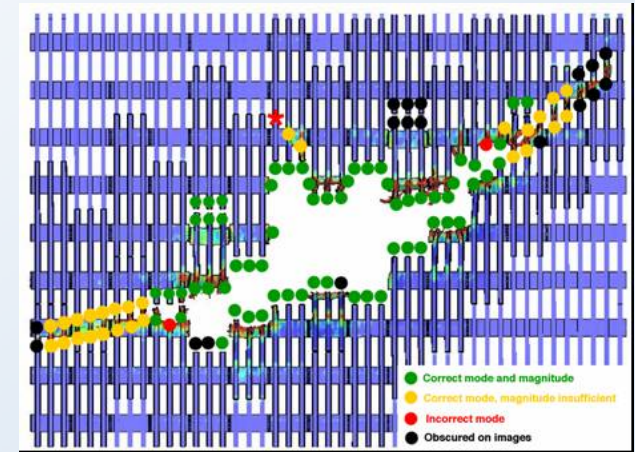
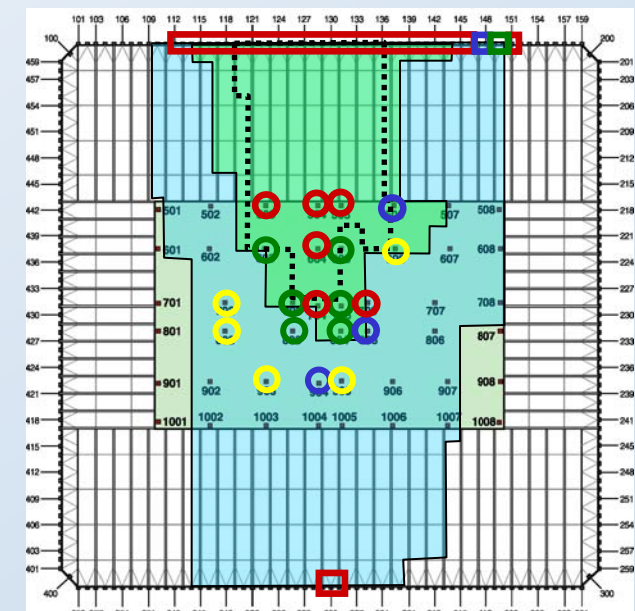
WTC 1 Probable Collapse Sequence

Aircraft Impact Damage

- ❑ Exterior columns, floor sections, and core columns were severed through the building center. An exterior panel was severed at the south wall.
- ❑ Fire protection was damaged through the building center to the south exterior wall.
- ❑ Loads were redistributed mostly to adjacent columns and the hat truss resisted downward movement of the north wall.
- ❑ North and south walls carried 7% less load, east and west wall carried 7% more load, core carried 1% more load.

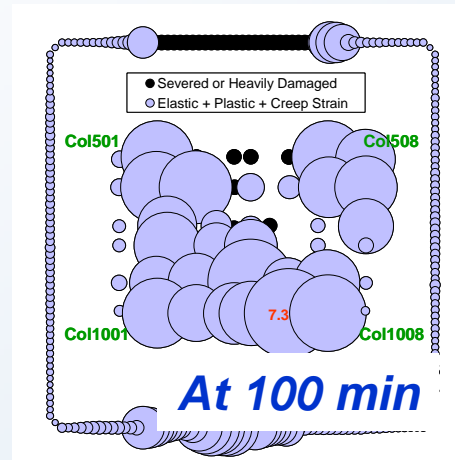
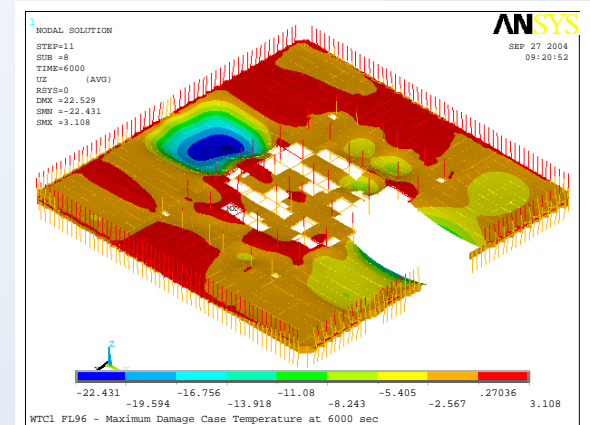
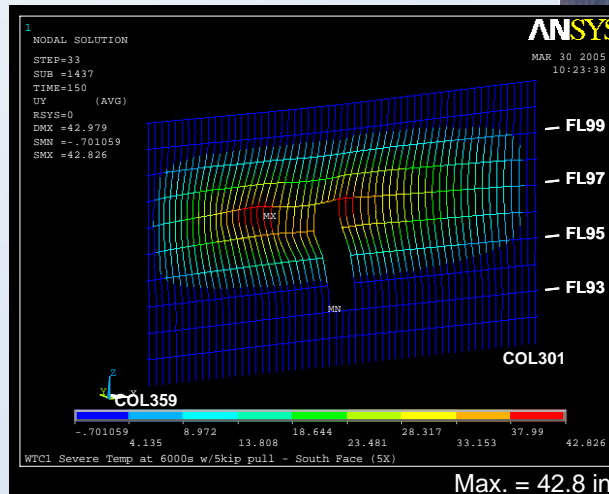
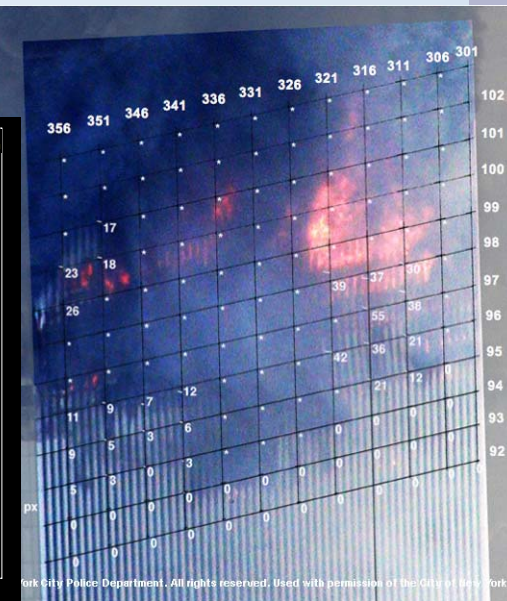
WTC 1 Probable Collapse Sequence (cont.)

Thermal Weakening

- ❑ Core columns developed high plastic and creep strains, after initial thermal expansion. Hat truss resisted core column shortening.
- ❑ Long span south floors sagged and pulled inward on the south exterior wall after the fires reached the south side.
- ❑ The south wall bowed inward due to inward pull by intact sagging floors.

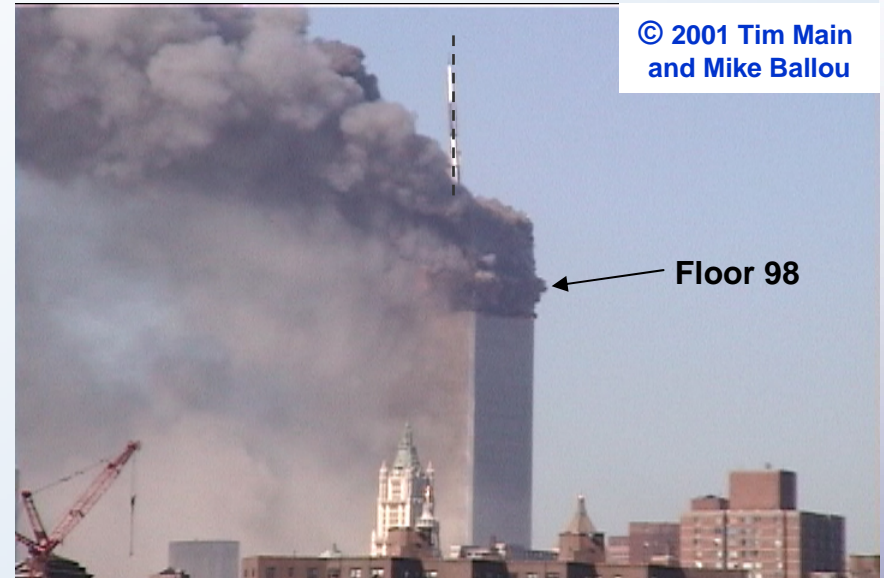
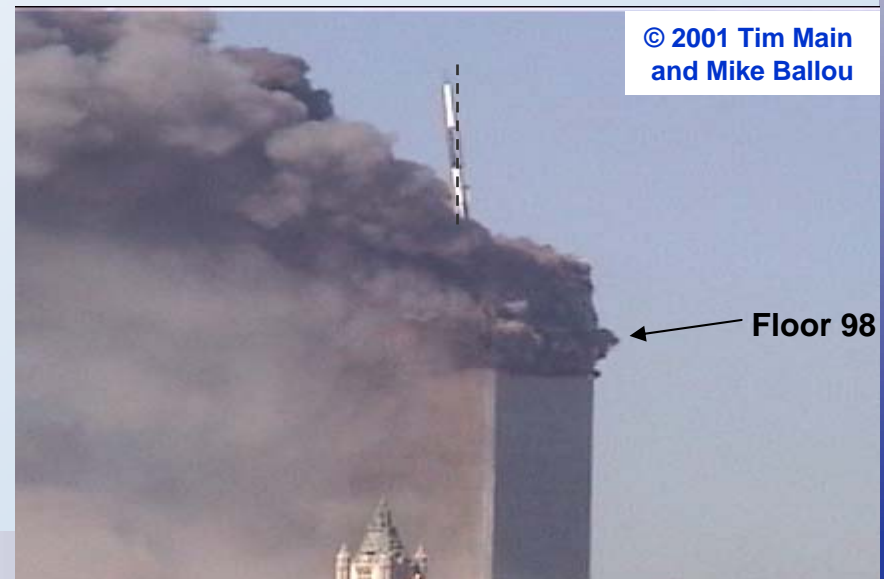
WTC 1 Probable Collapse Sequence (cont.)

Collapse Initiation

- ❑ The south wall buckled and transferred its loads to the weakened core through the hat truss and to the adjacent exterior walls through the spandrels.
- ❑ The upper building sections began to tilt to the south as a rigid block.
- ❑ Instability progressed along the east and west exterior walls.
- ❑ Collapse ensued as the released potential energy could not be resisted by the structure.

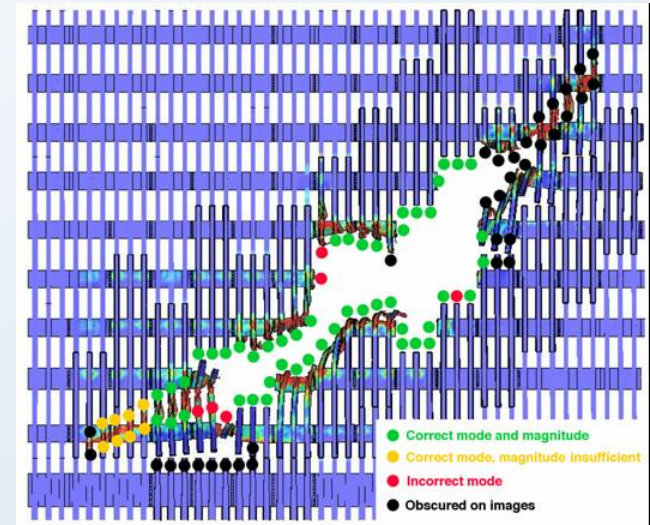
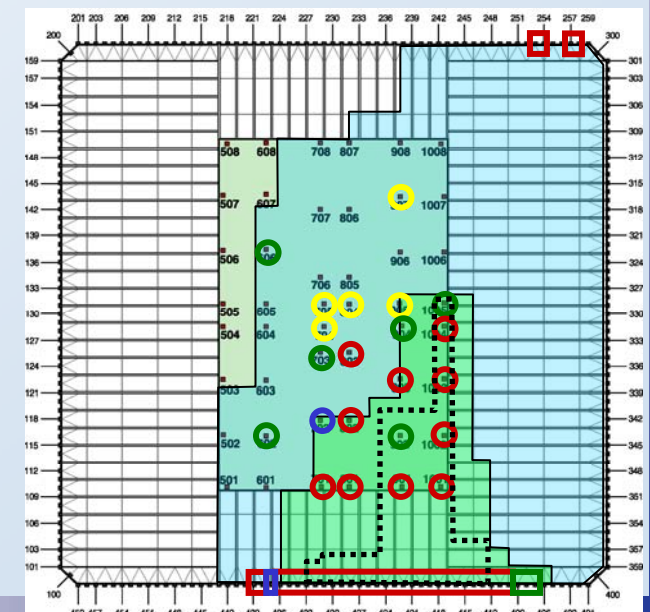
WTC 2 Probable Collapse Sequence

Aircraft Impact Damage

- ❑ Exterior columns, floor sections, and core columns were severed through the southeast corner and east side of the building.
- ❑ Loads were redistributed mostly to adjacent columns and the east exterior wall.
- ❑ Fire protection was damaged in the east side of the building.
- ❑ After impact, the core was leaning slightly toward the east and south walls. The exterior walls restrained the tendency of the core to lean through the hat truss and intact floors.
- ❑ East wall carried 24% more load, south and west wall carried 2-3% more load, north wall carried 10% less load, and the core carried 6% less load.

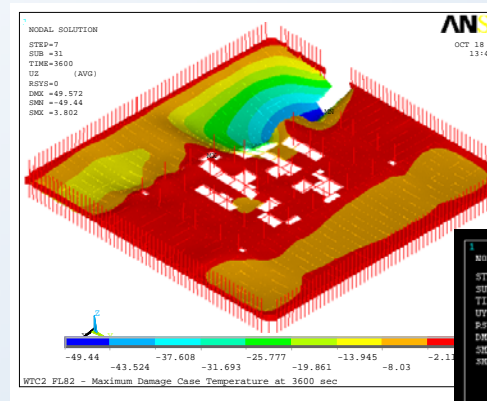
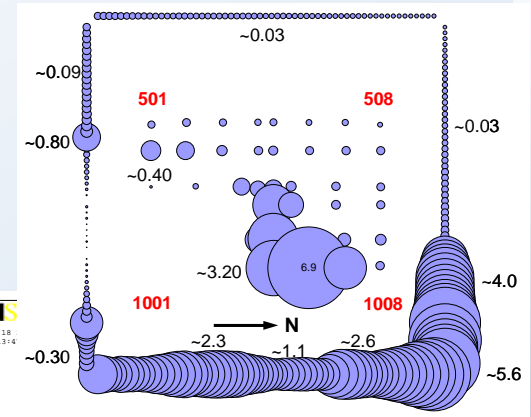
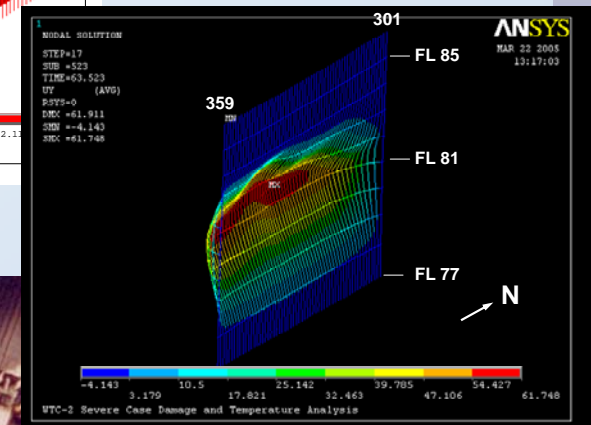
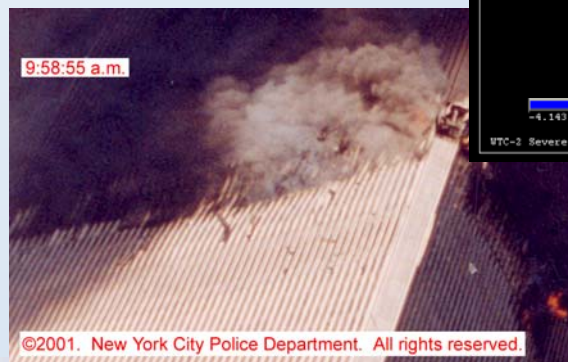
WTC 2 Probable Collapse Sequence (cont.)

Thermal Weakening

- ❑ Several core columns on the east side developed high plastic and creep strains, after initial thermal expansion.
- ❑ The long-span east floors sagged and pulled inward on the east exterior wall shortly after impact, due to the damage and fires on the east side.
- ❑ About 1/3 of the remaining Floor 83 connections to the exterior wall failed.
- ❑ The east wall bowed inward due to inward pull by intact sagging floors.

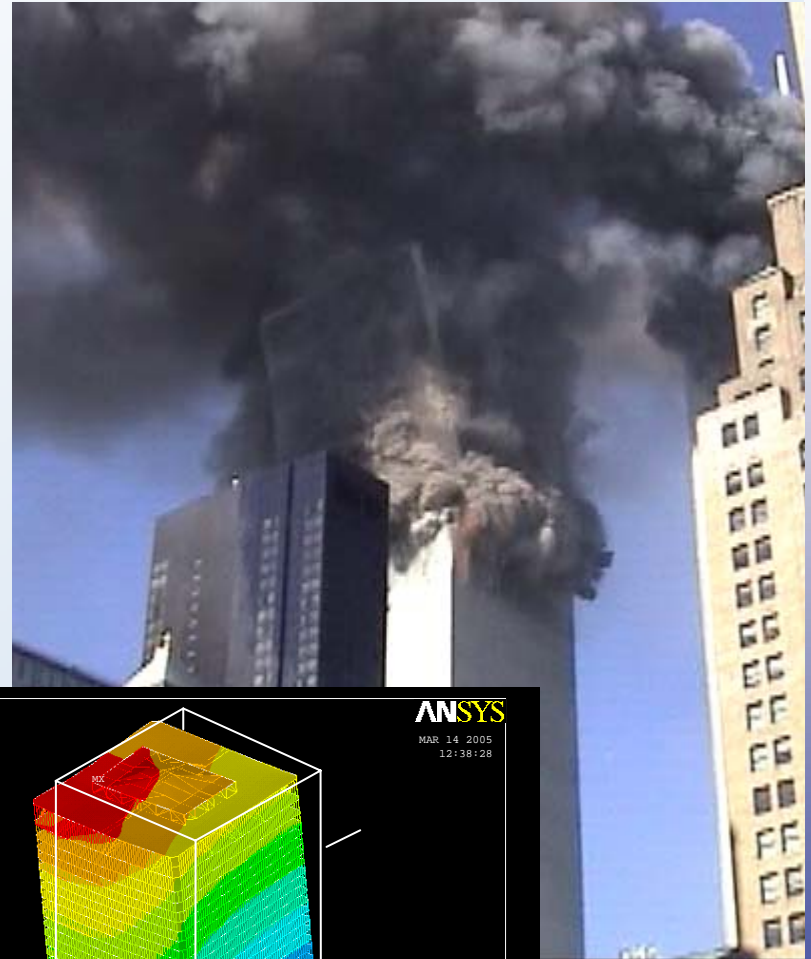
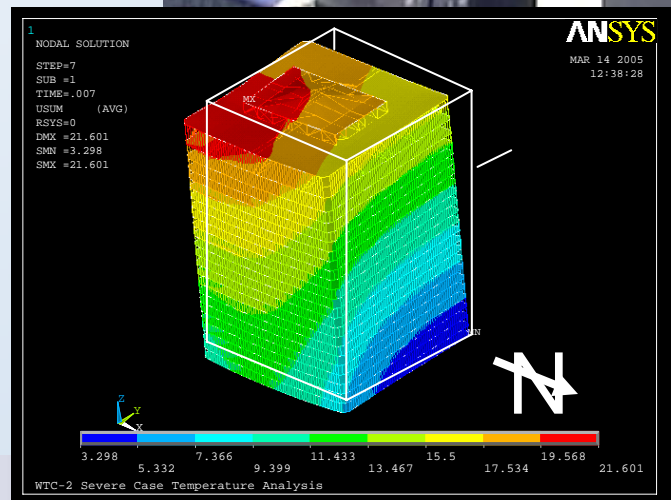
WTC 2 Probable Collapse Sequence (cont.)

Collapse Initiation

- ❑ The east wall buckled and transferred its loads to the weakened core through the hat truss and to the adjacent exterior walls through the spandrels.
- ❑ The upper building sections began to tilt to the east and south as a rigid block.
- ❑ Instability progressed along the north and south exterior walls.
- ❑ Collapse ensued as the released potential energy could not be resisted by the structure.
